YOUR INSPECTION REPORT

Paul Bernard

Bernard Inspections
117 Carey
Canmore, AB T1W 2R3

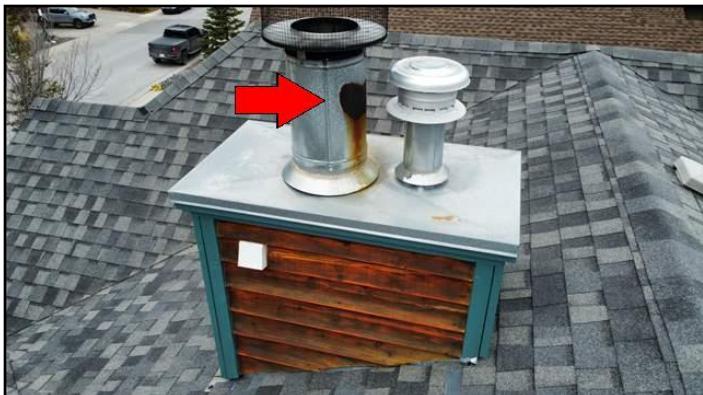
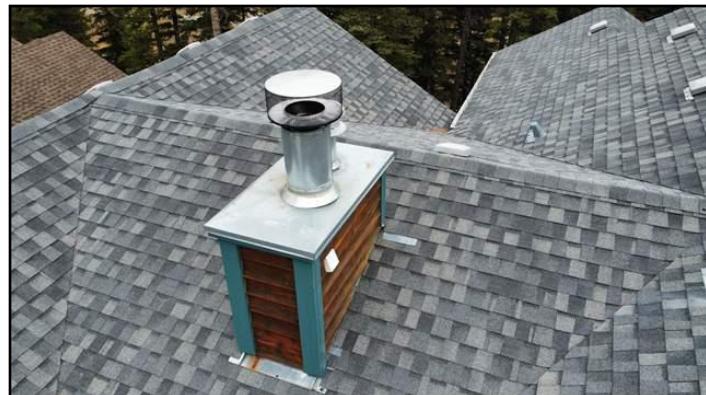
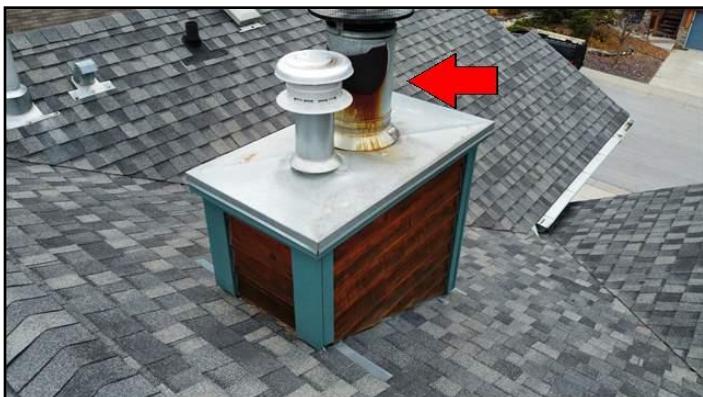
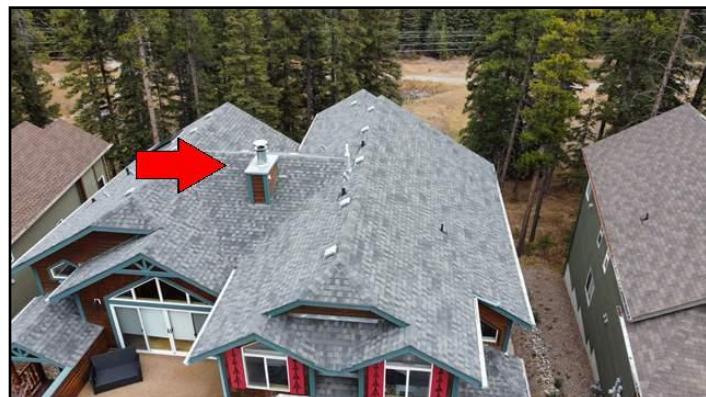
Condition: • It was observed that while this is a shared roof there is what appears to be a hole in the flue of the chimney of the neighboring house. The neighbor was not home to be able to try to access the roof by way of their front deck. It is advised to engage a contractor sooner than later to further evaluate.

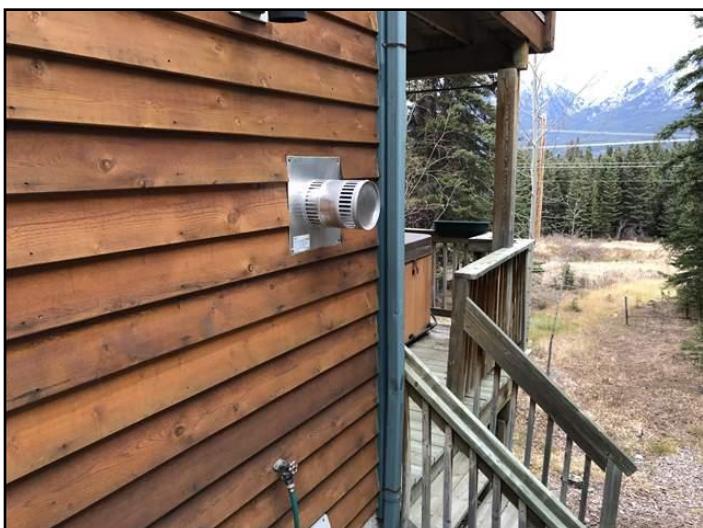
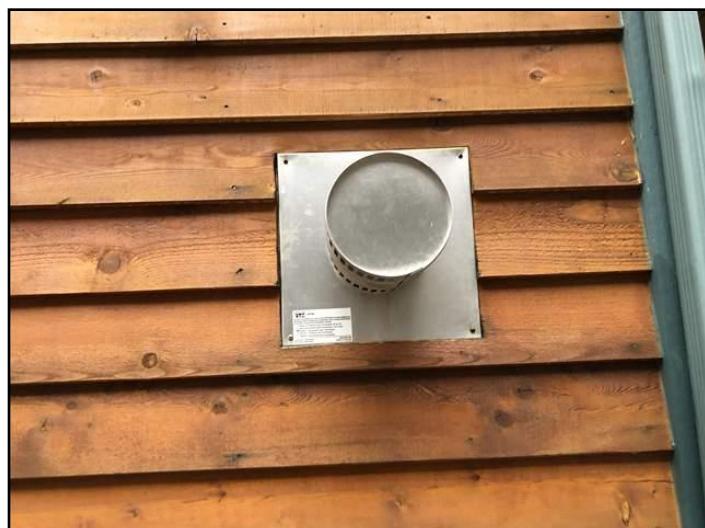
Vent for Basement Fireplace

Condition: • It was observed that there is no caulking on the exterior vent which allows for cold air to penetrate the home. It is recommended to caulk as soon as practical. Images and thermal imaging attached for reference.

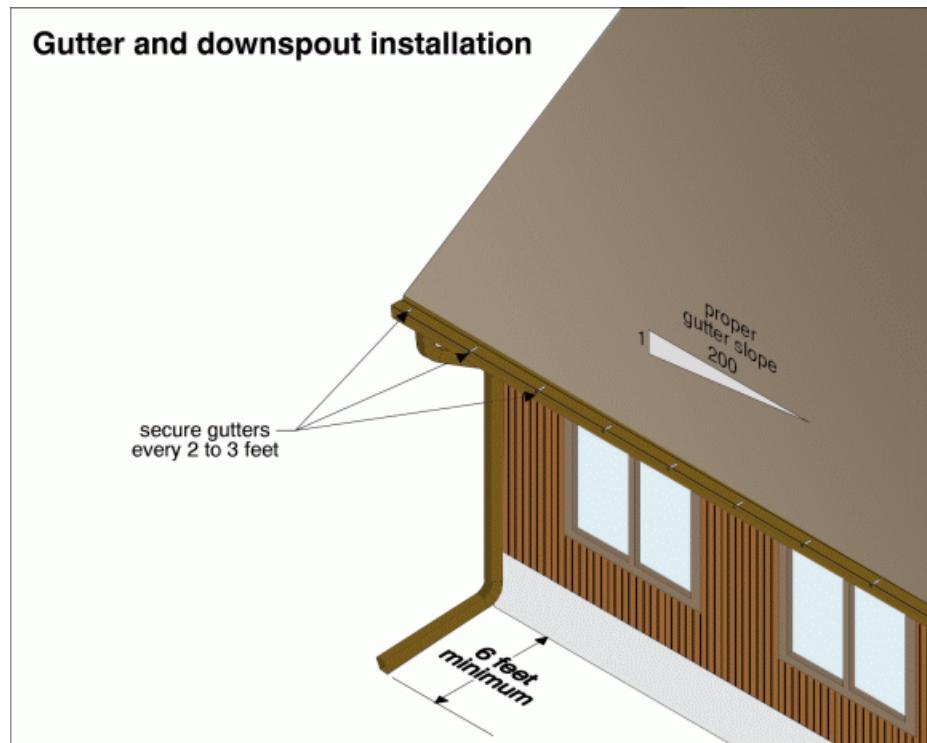
We observed there is one downspout that is recommended to be reattached. At least four feet is the recommended length for a downspout extension for away from a house to allow for proper drainage.

Downspout extension too short

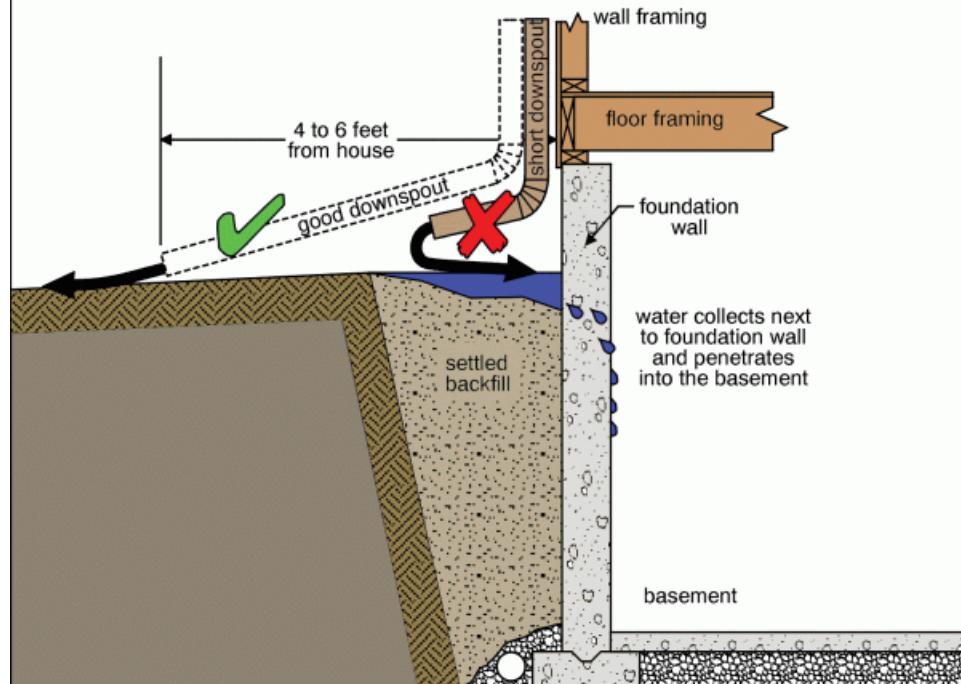
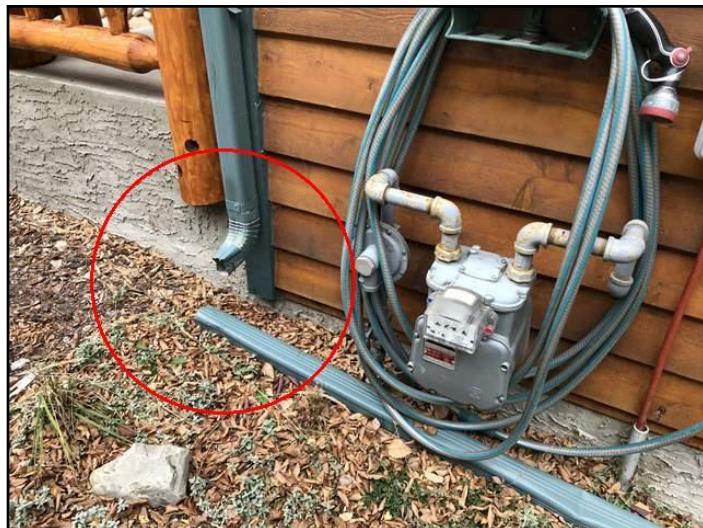
Discharge too close to building

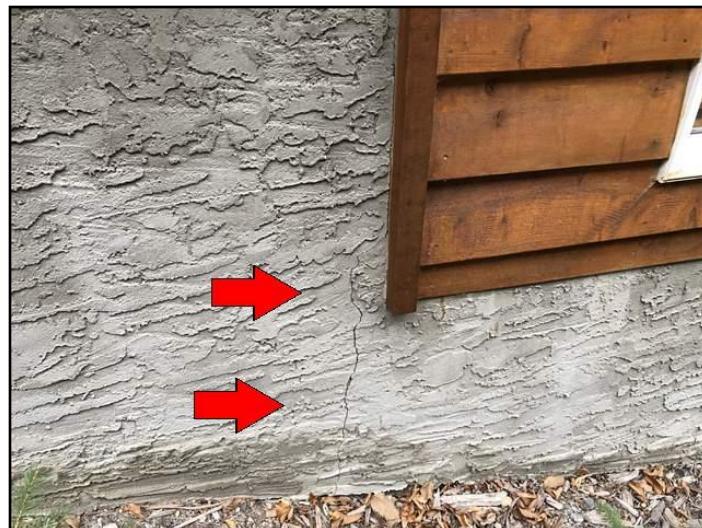
• Cracked
Minor vertical crack on foundation wall. This does not appear to be structural, and may have occurred from settling. Otherwise, an epoxy injection into the crack can stop moisture/water entry. Ensure exterior grading is sloped away from home to ensure water is directed away to prevent moisture entry.

Cracked

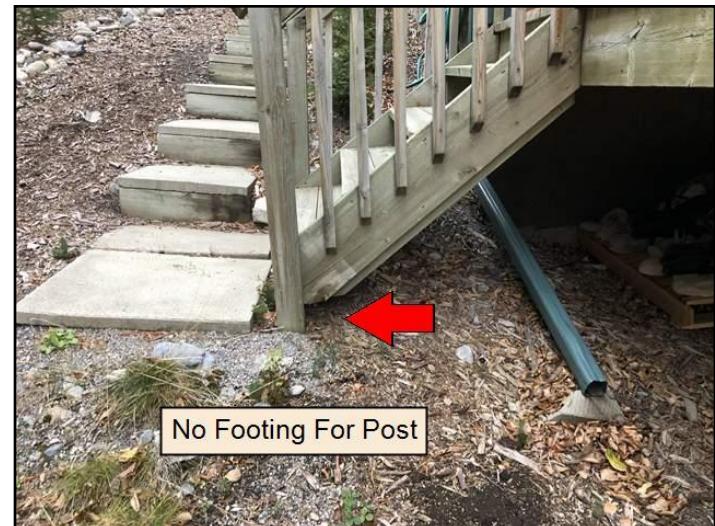
Hand Rail Post

Condition: • It was observed that at the rear main floor deck which houses the hot tub, that the stairs up are uneven and there is a leak perhaps with the equipment which was just replaced as per a conversation with the seller, Pierre. There are no footings visible for the two post as indicated in the photos which could have allowed for the stairs to move and slope. The deck itself does not appear to be sloped. It is advised to have a contractor out for further evaluation for these items as well as the fastener to the wall securing the beam as it is also load bearing. The seller, Pierre indicated he would be in touch with the hot tub company with regards to the hot tub as they were just there three weeks ago.

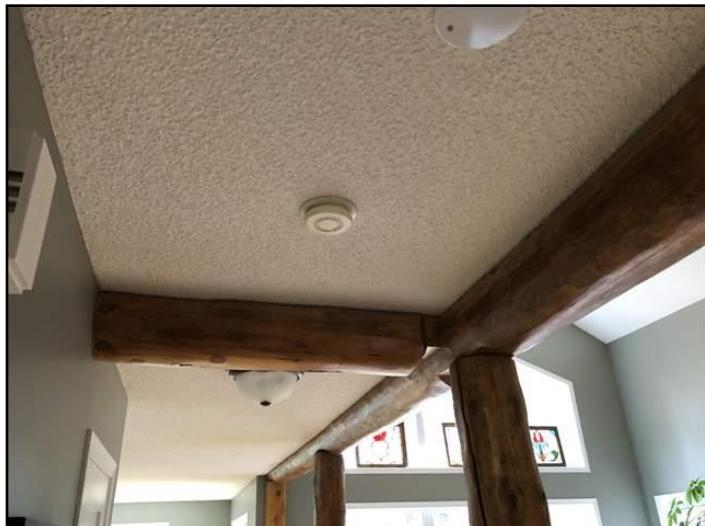
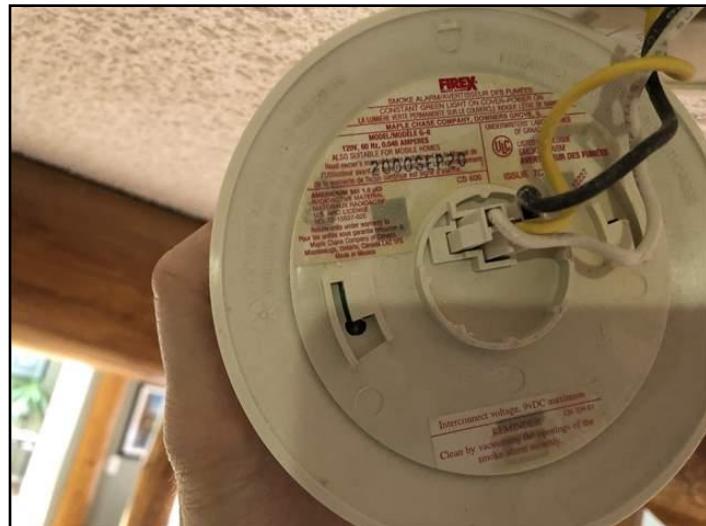
While smoke detectors were present on all floors, they appear to be original to the home and are therefore expired. Only the basement smoke detector tested out, while the other two did not sound off. Recommend replacing old detectors with new Combination Smoke/CO Detectors upon expiration or before. Detectors are now available with a built-in 10 year lithium battery, working detectors should be installed for every floor of the home.

Past life expectancy

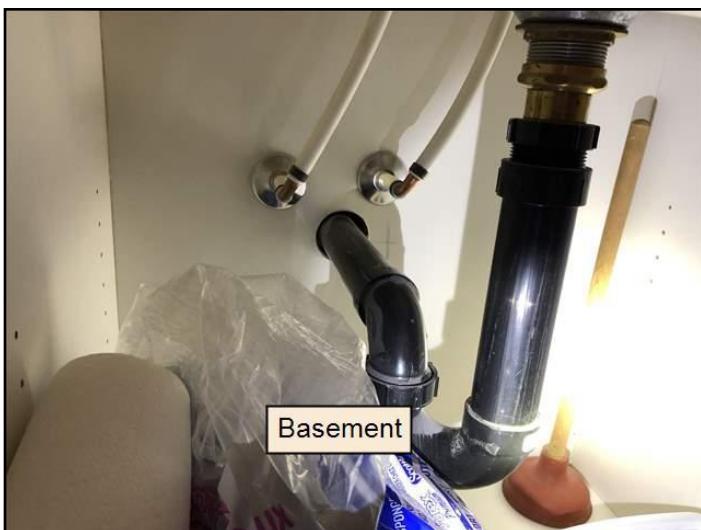
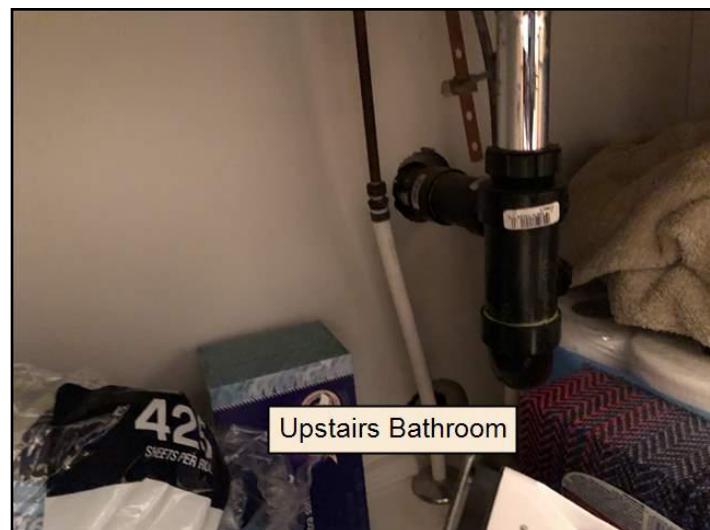
It was observed that there are no water shut off valves located below the sinks in both the upstairs bathroom and the basement wet bar. Recommend consulting a qualified plumber to have these installed. This will allow the home owner or contractor to fix any issues that may arise without having to shut off water to the whole house. Photos attached for reference.

Missing or cannot be located

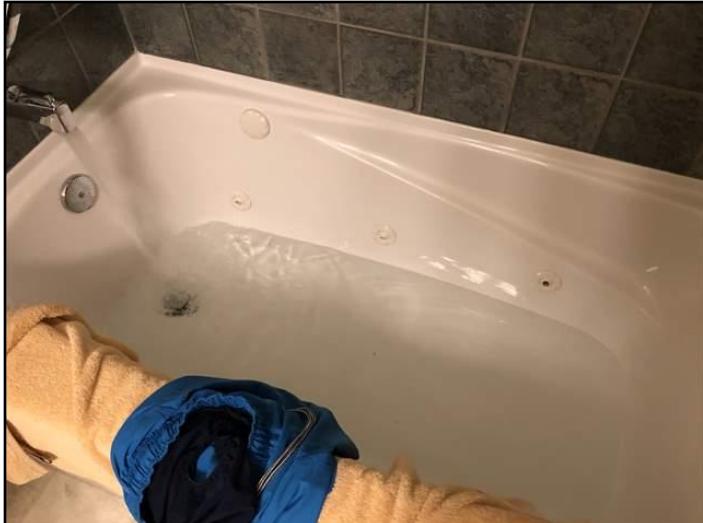
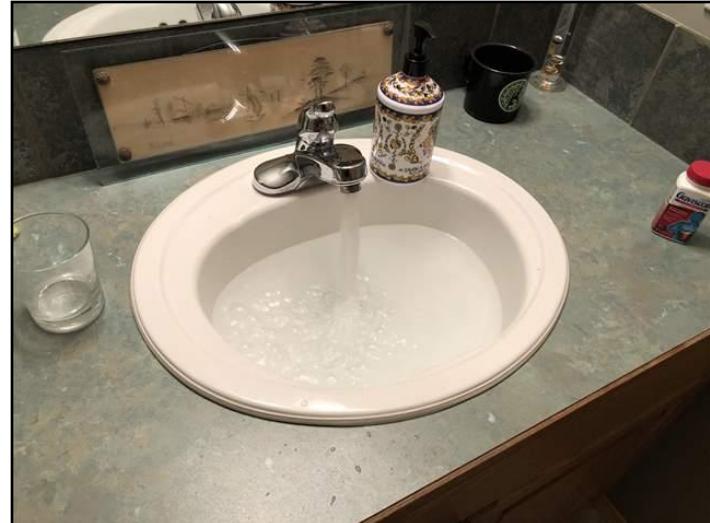
The master bathroom bathtub and sink faucet in the upstairs bathroom have a slow drain and potential blockage. It is possible they are connected on the same wall and apart of the same line. Recommended to have the lines snaked. Photos attached for reference.

Slow drain

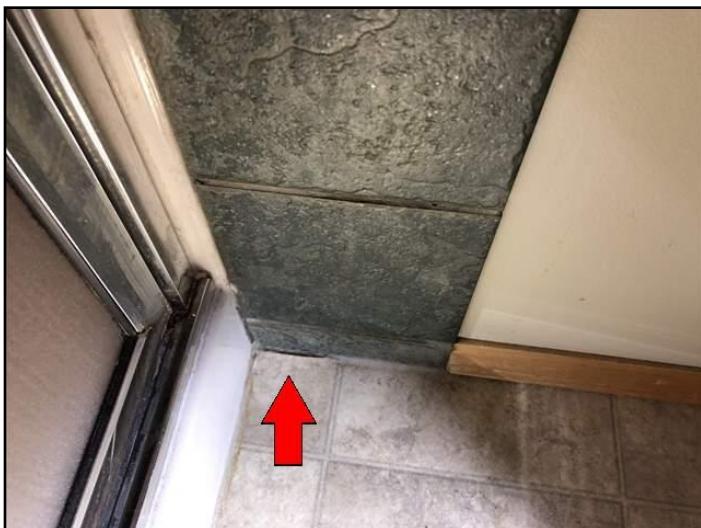
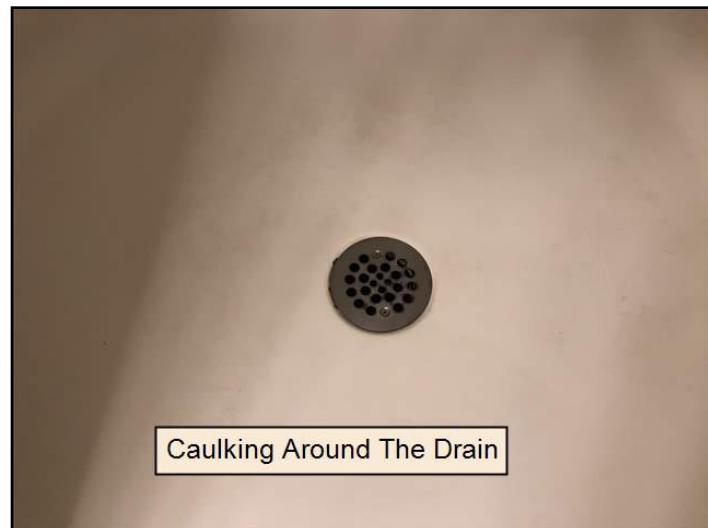
It was observed in the master bedroom shower that just outside the caulking has worn away and the flooring has been peeling away. It is recommended to fix sooner than later as those conditions and location allow for mold come about to thrive and propagate. Also, is a photo of the drain in the bathroom that needs to be caulked. Photo attached for reference.

Caulking loose, missing or deteriorated

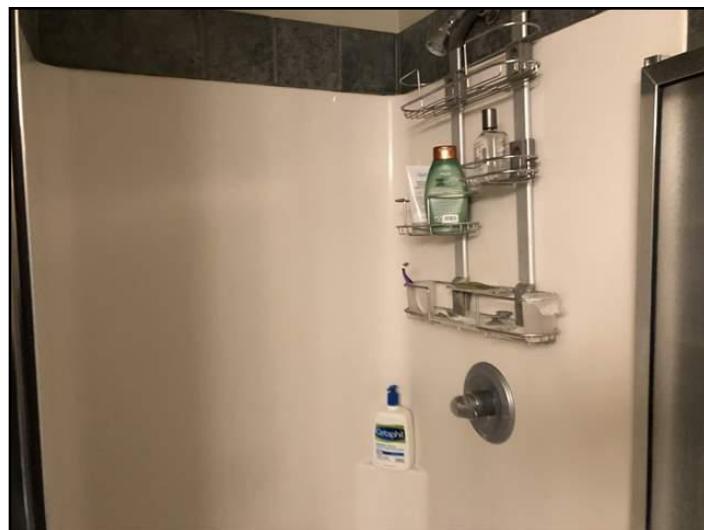
Condition: • Again in the master bedroom the shower head sputters out water. While functional it is advise for cleaning of calcification or perhaps replacement of shower head.

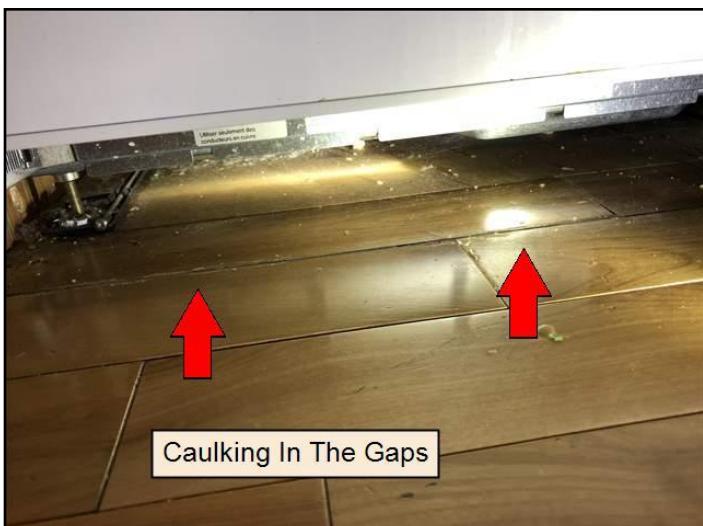
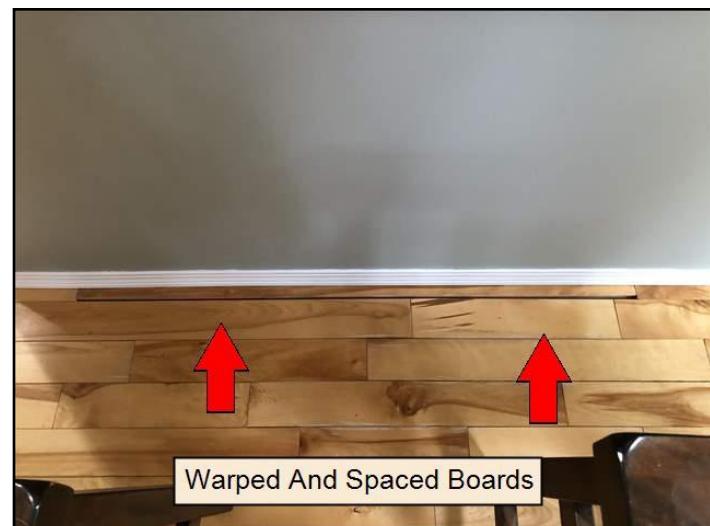
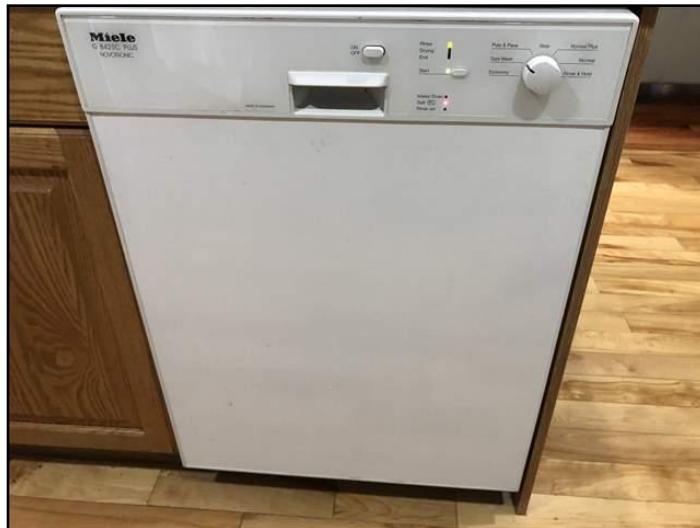
When tested the dishwasher ran without issues. However, it was observed that the dishwasher is not mounted to the top of the counter top from underneath in order to secure. It appears that there was a leak from the previous dishwasher which has caused some of the hardwood flooring boards to warp and bend. It is recommended to secure the dishwasher and look at available options to repair flooring. Photos attached for reference.

Loose
