YOUR INSPECTION REPORT

Paul Bernard

Bernard Inspections
117 Carey
Canmore, AB T1W 2R3

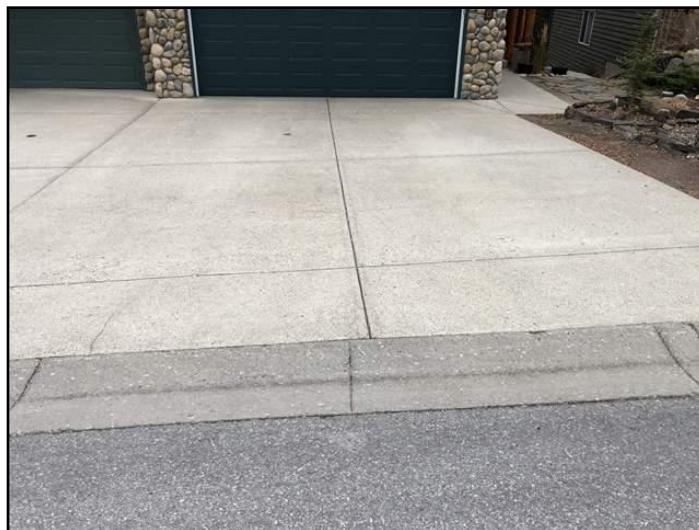
Concrete driveway and walkway. Clear the snow with a shovel / broom. I don't recommend using snow/ice melting salts, as it can cause the surface of the concrete to spall and become crumbly over time. It was observed that on both sidewalk and driveway there are small cracks from settlement or possibly heaving; you will want to monitor for any big changes.

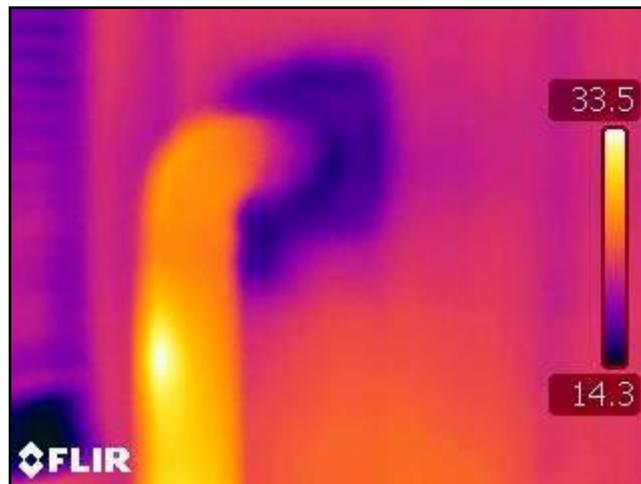
Condition: • It was observed that there is no caulking on the exterior vent which allows for cold air to penetrate the home. It is recommended to caulk as soon as practical. Images and thermal imaging attached for reference.

Interior of Vent Showing Cold Air

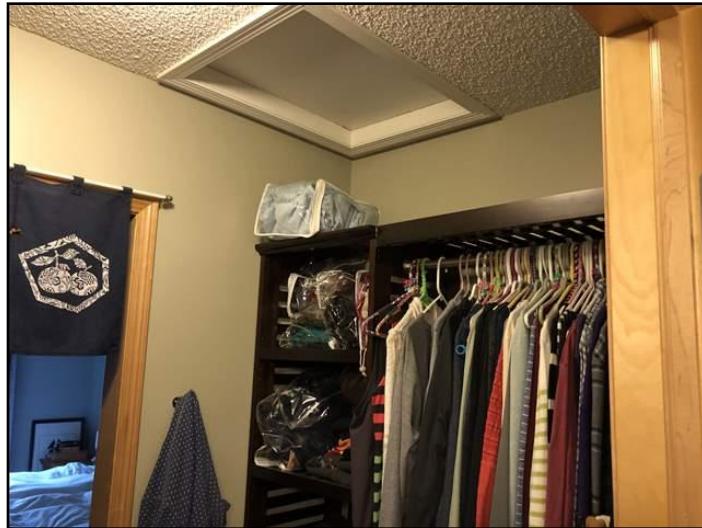
Inspected from access hatch

There were no signs of water leaks or condensation in the roof space when viewed from the attic hatch. Access was limited to the attic hatch because of the closet shelves impeding access as well as the location and size. The hatch itself was well insulated and heavy to allow for a good seal. When measured there was 11 inches of insulation evenly spread through the attic.

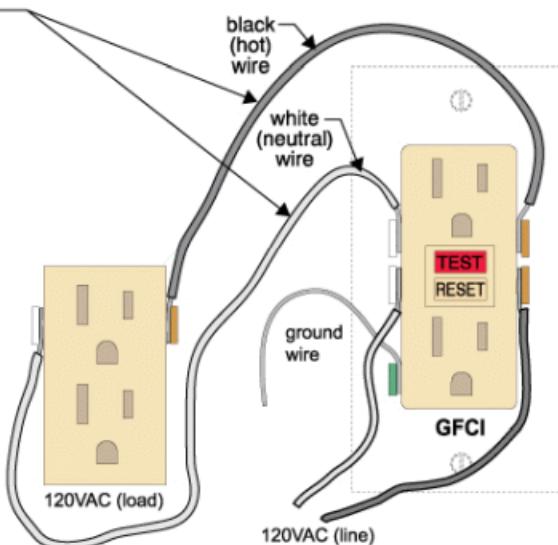
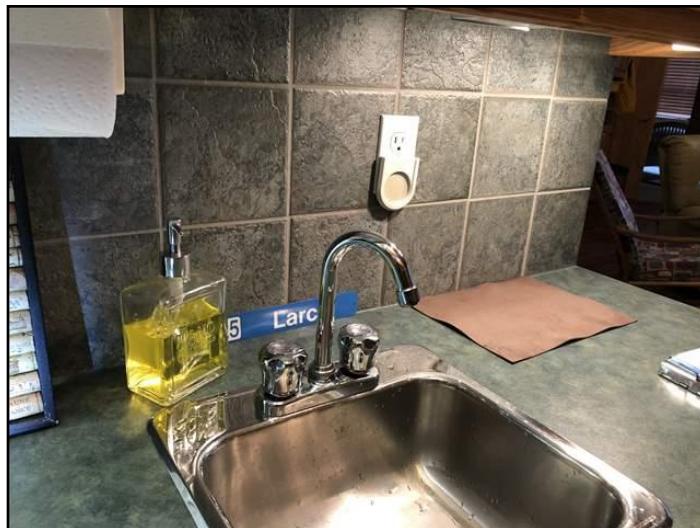
No GFCI/GFI (Ground Fault Circuit...

Condition: • [No GFCI/GFI \(Ground Fault Circuit Interrupter\)](#)

Task: Replace

if the GFCI is in the panel, the entire circuit will be shut down to reduce the risk of electric shock

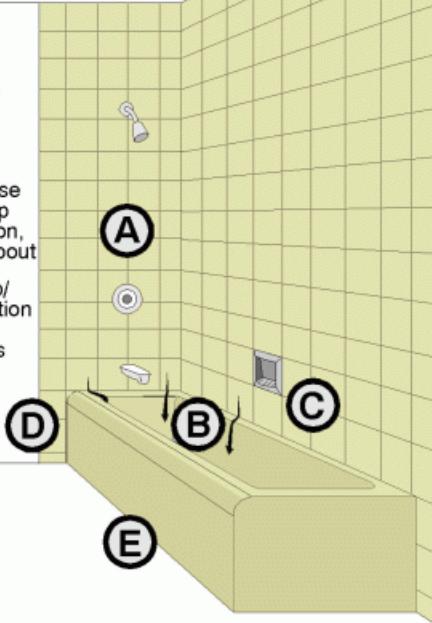
Slow drain

Condition: • [Slow drain](#)

The master bathroom bathtub and sink faucet in the upstairs bathroom have a slow drain and potential blockage. It is possible they are connected on the same wall and apart of the same line. Recommended to have the lines snaked. Photos attached for reference.

Implication(s): Chance of water damage to structure, finishes and contents
